Case History 169

Iron and Steel Foundry - Machine shop

Machine Shop

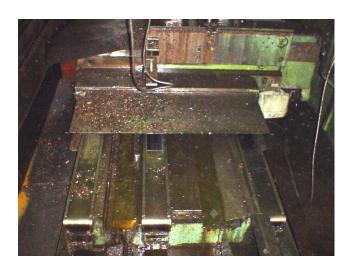
CNC Machine

When carrying out the machining operations chips fell on the slide ways and guides. This resulted in costly damage to the machine and production of non-conforming product. Originally a large rubber shield covered the whole area to prevent this problem occurring, but over time cutting fluids and abrasion took their toll and the rubber disintegrated.

Six EXAIR Super Air Knives Model BP110006 were mounted on the carriage (three each side) above the slide and guide ways. The Super Air Knives completely covered the six individual slide ways with a uniform sheet of high velocity air so the chips would be blown off as the carriage of the machine was moved.

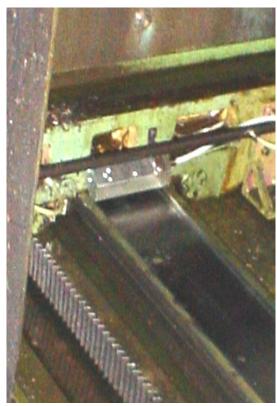
Chips seen on slide ways
