## Case History 102

Automotive-Lighting manufacturers

Tail, stop, indicator, fog and headlights for all types of vehicles.

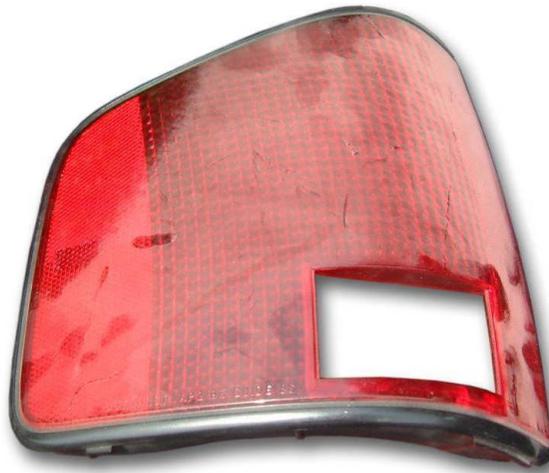
Normally three major parts make up any lighting unit; the reflector lens which is also the rear housing, the lens cover (shown above) and the electrical components. There are at least three potential applications common to lighting manufacturers depending on the “local styles” and manufacturing process, but there can be more.

Lens cover. In the above photograph there is a black edge to the lens cover (could also be red). This is paint which is applied to the underside of the cover to make a neat edge. For good paint adhesion and minimal overspray the cover must be static free and the dust removed. If not, the part is reworked or scrapped.
